FIELD CHANGE ORDER

Reference No. : FCO74200006
Date : July 2002
Product Group : 742

Transport wheel problems with generator cabinet 40E.

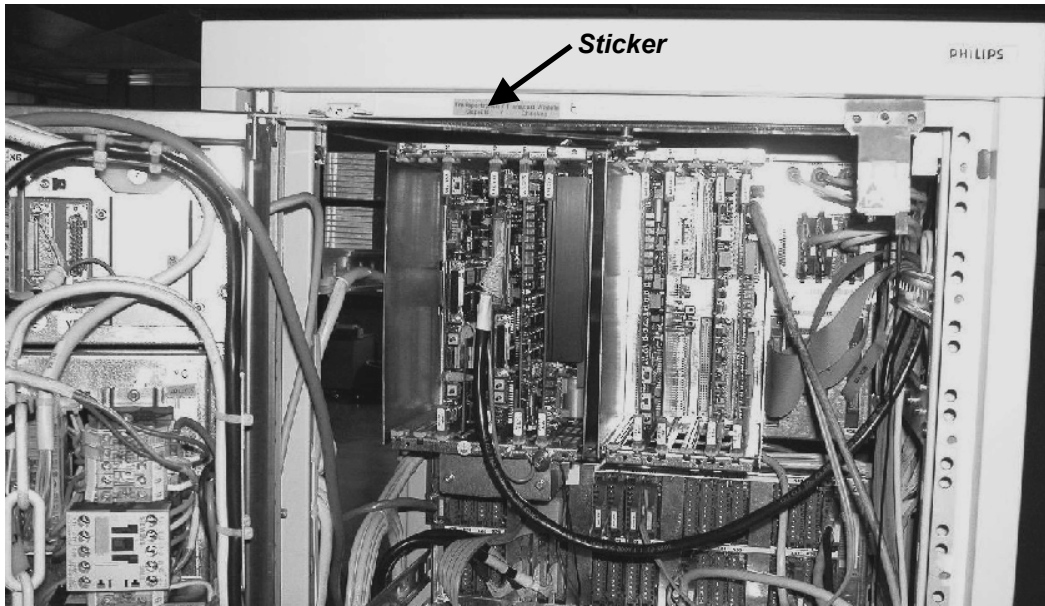
Illustration 1

- Check for sticker '**Transport Wheels Checked**' at the upper left corner of the cabinet (illustration 1).

- Stick the sticker at the upper left corner of the cabinet (illustration 1 on page 3).

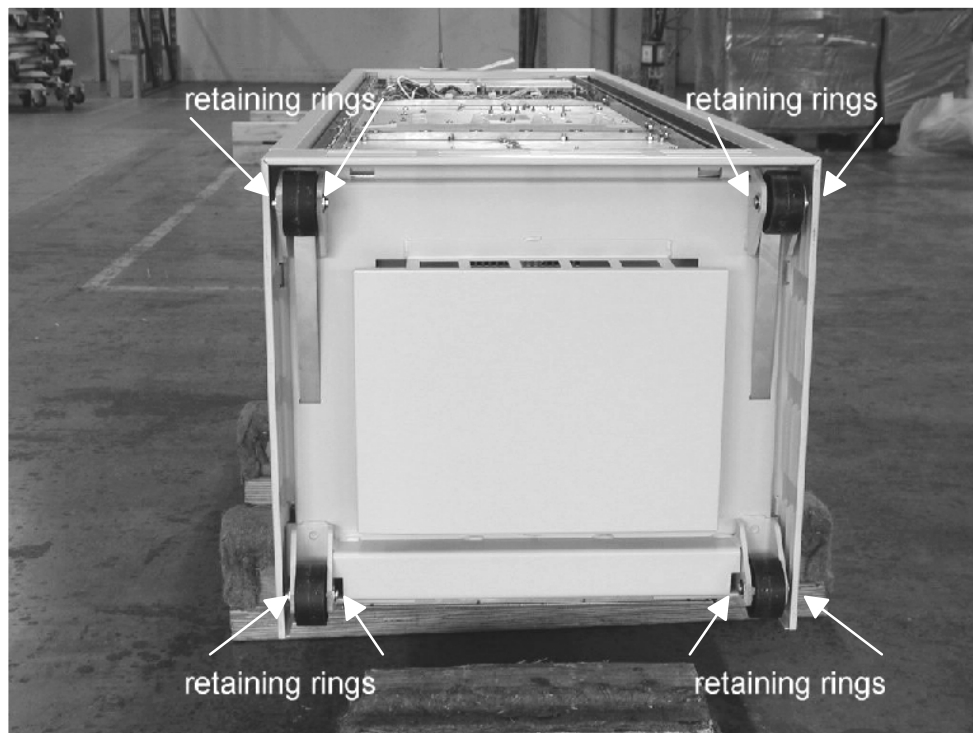
Illustration 4

- Check of all four transport wheels (illustration 4).
The four transport wheels are secured with retaining rings on the axles.
The retaining rings are located on the left-hand and right-hand side of each axle (8 pieces).

The retaining rings must encircle the axle and sit securely in the grooves of the axle (illustration 5).

- In case the retaining rings do not sit securely in the grooves (illustration 6), use suitable pliers to insert them properly in the groove of the axle (illustration 5).

- It may also happen that retaining ring and washer are missing completely. In this case order retrofit kit "Transport wheels" or buy the parts locally and replace any missing parts.
